H. P. Berlage and Amsterdam Stock Exchange, a reflection on the meaning of Construction

Ana Rodríguez García

THE AMSTERDAM STOCK EXCHANGE IN THE PERIOD 1898–1903. ANALYSIS OF THE CONSTRUCTION PROCESS BASED ON THE PHOTOGRAPHS OF THE BERLAGE ARCHIVE IN THE NAI

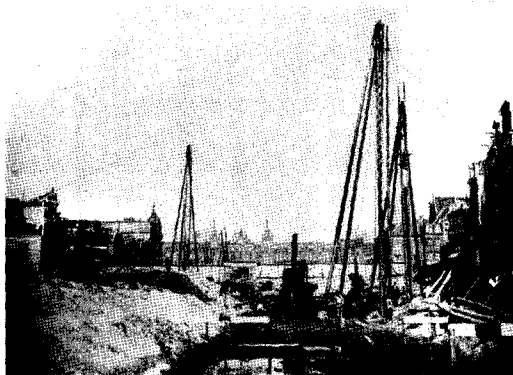
Figure 1

Looking toward Dam street. In the background we see the Central Station building, built in 1886.

Phase of driving the piles of the foundation. Images 1, 2 and 3. The image shows a level at the top of the piles before their heads are joined together below street level.

Earth moving, excavations, and auxiliary elements for on site ranging such as crossbars with levels, 3 the guides without the pile driver, and the second, to the right, wooden structures for driving the piles. Looking at the piles, the one at the rear to the left appears to have been installed recently, the pile driver and the pile are suspended. In the foreground, some workers to the right appear to be plumbing the guides. 2 auxiliary machines, possibly for vertical lifting and pounding of piles with combustion engines.

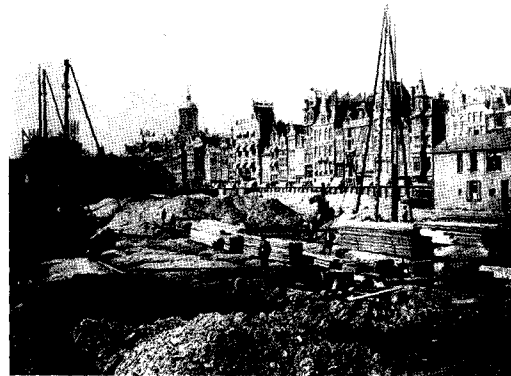
Figure 2

Looking toward Damrak. To the right, we see the Algemeene building, built in 1886, destroyed in a fire in 1960, the department store of C&A currently stands in its place

Perspective is a continuation of Image 3.

Phase of driving the piles of the foundation. Images 1, 2 and 3. The image shows a level at the top of the piles before their heads are joined together below street level, similar to Image 1.

Earth moving and excavations. 3 wooden structures installed for driving piles, the one to the right with guiding tracks, pile-driver and a half driven

pile. 2 auxiliary machines for lifting and driving the pile-driver. In the background and to the right there are warehouse-like buildings that surely existed beforehand and which remain during the works.

With regard to Image 1, there are stockpiles of different types of wood, planks piled for the top level of the foundation, ribbing for this same level and large boards to join transversally various piles. Row of piles and in the foreground an area of piles with water on the surface.

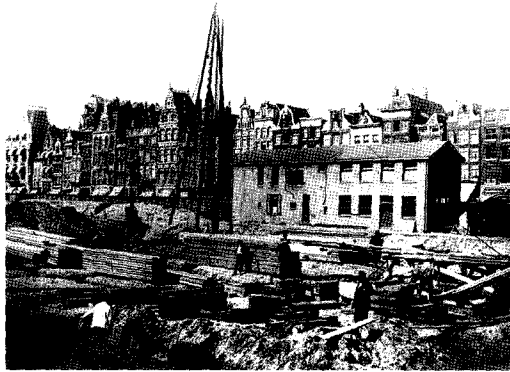
Figure 3

Looking toward Damrak. To the left we see the De Algemeene building, also by Berlage, built in 1886, burned in a fire in 1960, the department store of C&A currently stands in its place.

Perspective is a continuation of Image 2, more to the right. Warehouse-like building that could have existed beforehand and which remains during the works.

Phase of driving the piles of the foundation. Images 1, 2 and 3. The image shows a level at the top of the piles before their heads are joined together below street level, similar to Image 1 and 2.

With regard to Image 1, there are stockpiles of different types of wood, planks piled for the finished level of the foundation, ribbing for this same level and large boards to join transversally various piles.

Row of piles in the foreground to the left where there are two workers.

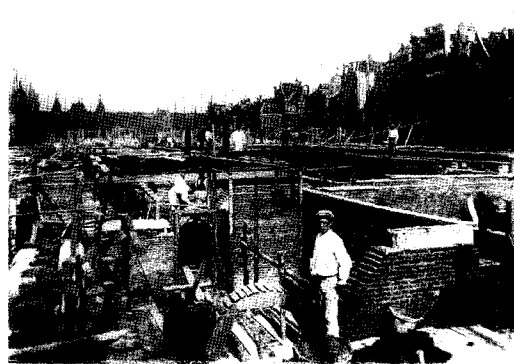
Figure 4

Looking toward Dam. Perspective similar to Image 1 with the Central Station in the background.

The status of the works corresponds to the basement and the first floor. The works progress from Dam in the background where we see already installed the wooden structures for erecting the stone pillars of the ground floor on top of the first flooring with provisional scaffolding. In the middle ground, the metallic beams of the flooring without an auxiliary floor. In the foreground, an area without flooring where they are laying bricks and placing the framework to form the arches. Stockpiles of bricks under the metallic beams of the flooring. We see also that wooden posts have been installed around the perimeter for the scaffolding.

There are two framework structures prepared for forming arches, and a third one to the left that is on the floor among other materials. Judging by the quality of their construction, they may be reused to form arches in spans of the same width (the first frame is marked 15M). The group in the background is checking the position of the framework, while the worker in the foreground has begun to place the first layer of the arch with bevelled brick. The walls have been built higher on the left where the area has been left free of xxx in order to connect the arch to the wall, which in the upper floors are visually reinforced with a piece of stone which serves as the base for the arches. In the basement, which is for services and installations, stone pieces have not been placed, as we can see from the image.

In Image 4, the works advance from the Dam in the background where we can already see the wooden structures for erecting the pillars of the ground floor on the first shared base with a temporary scaffolding for working. In the middle ground, they are about to finish laying the metallic beam of the floor. In the foreground, we see the area without flooring where they are laying bricks and placing framing for creating the arches. This order is verified in Image 8 where the work advances from the back. We can see the temporary planking for working on the flooring at the same height as the flooring in the foreground. This shows an isolated planking for crossing rather than a continuous work surface. It is also confirmed in Image 10 where from the main hall, we can see the assembly of the exterior structure of the roof of The Passage.

The auxiliary structures are generally made of wood, except for a few machines and special pieces. They are remarkable because of their extraordinary austerity and simplicity for a work of this size and importance. They are interesting not so much in and of themselves but in the way that they were used to rationally prepare the work sites. In addition to a certain degree of systemisation, they sought to execute the works well. This was particularly important in an architecture without finishing work. Thus, in the areas with groups of pillars or buttresses, before erecting one of them, they prepared the totality of the structures necessary for working on each pillar. In the case of the wooden framework for the repeated arches under a certain size, judging by the quality of their construction and the information provided by Image 4 in which the framework in the foreground is marked with 15M., they appear to have been built in the shop and reused during the work.

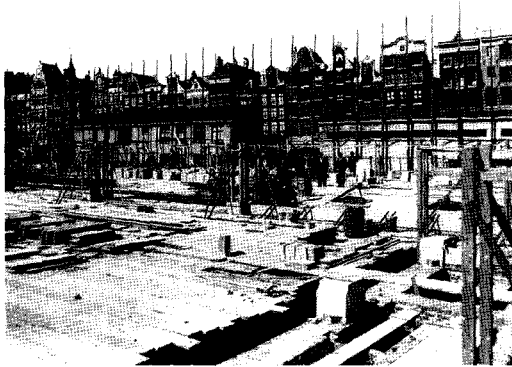
Figure 5

Looking toward the main entrance on Beursplein street. It corresponds approximately with what we see in the background of Image 4.

Works on the beginning of the ground floor. First flooring with temporary planking for workmen (in some areas we can see where the metallic beams are embedded in the walls). Preparation of necessary auxiliary measures.

The wooden structures for the buttresses-pilasters of the central wall of the two smaller halls have been prepared. The wooden posts around the perimeter for the scaffolding, and the auxiliary machinery for hauling and lifting have been installed. On this floor, they have begun to place the pieces of stone and we see the first stockpiles.

Importance of the wooden auxiliary means in the placement of stone and in the laying of brick, both visible brick and finishing brick, inside and outside the building.

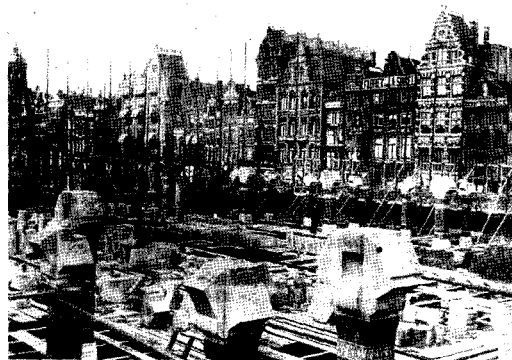
Figure 6

Looking toward Damrak. To the right we see the Algemeene building, also by Berlage, built in 1886 and destroyed by fire in 1960.

Works on the beginning of the ground floor. First floor with temporary planking for workmen (in some areas we can see where the metallic beams are embedded in the walls). Installation of wooden posts on the perimeter for scaffolding

Stone works and stockpiling of materials.

The main issue of the photograph is the stonework. There are stockpiles of stones and other materials, possibly bricks. They are erecting all elements of the stone pillars-columns (base and capital of softer stone, and shaft of already polished and decorated granite). The stone elements come from the shop totally finished, including the decoration, in which there is a differentiation between the finish of the parts that will be visible and those that will end up embedded in the brickwork. Particularly noteworthy is the stonework on the capitals prepared to support the big longitudinal arches and the smaller transversal arches.

Holland is a country without stone. The traditional importance of masonry in construction took on a special relevance in the Stock Exchange because of its prominence in the building and its significance in this country. Images 6 and 7 tell us of Berlage's emphasis on the treatment of this material.

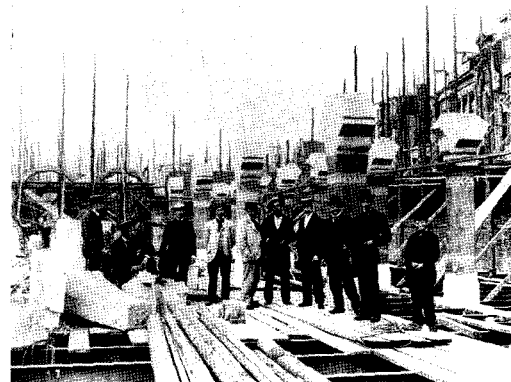
Figure 7

Looking toward Dam, from the perspective of the viewer.

Works on the beginning of the ground floor. First floor with temporary planking for workmen. The wooden posts around the perimeter for scaffolding have been installed. Stone works and stockpiling of material. The image was taken at the same time of the previous one (Images 6 and 7).

Meaning of stone in the building and the importance of the start of construction on the main

hall. All elements of the stone columns have been erected (base and capital of softer stone, and shaft of already polished and decorated granite). To the left, there stands out in the image a stockpile of stone elements where we see a corbel and we can verify that the pieces arrive finished from the shop, differentiating between the visible and hidden parts.

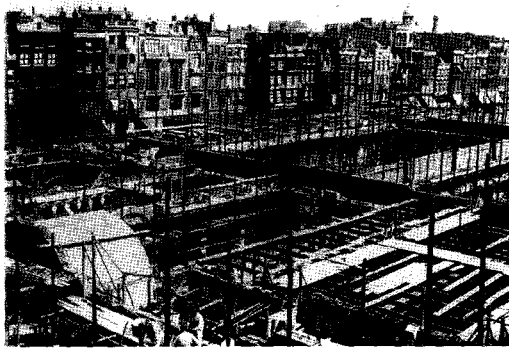
Figure 8

Looking toward the area of Dam street with the Damrak building in the background. Of all the photographs analysed, this is the one that is taken from the highest viewpoint.

Works in the upper portion of the ground floor (depending on the hall) and the beginning of the first floor.

Rooms with lower ceilings already covered with the metallic beams and tie-beams of the floor above. The wooden formwork for the brick barrel vault of the main hall of the central body has been prepared. In the big hall at the back, which has higher ceilings,

they continue to erect the walls. Wooden scaffolding.

The works progress from the back where we see temporary planking for workmen on top of the flooring at the same level as in the foreground. The planking is for crossing and does not offer a continuous surface for working. On this floor, the tie-beams are laid in two continuous sections and are supported in the central area by two joined metallic beams, making the floor look like a single piece. In the central body of the floor, which is more subdivided, to the left we see the upper portion of various arches, some with the framework still in place and the formwork prepared for the vault. Brickworks with two groups of people. In the foreground, to the right, we see a wall with a glazed brick face that is going to support a stone corbel which is in turn embedded into the wall.

Panoramic view from an elevated perspective that allows us to see the relative heights and sizes of the big halls and the rooms with lower ceilings, and understand the special complexity of the building. Different constructive systems such as metallic flooring and brick vaults determine the different character of the rooms.

the different levels of the brickwork. The stretches of coloured glazed brickwork are laid at this point as can be seen in Image 8. It is treated not as decoration added afterward, but as an integral part of the brickwork. (In the foreground of this image to the right, we see a wall with a surface of glazed ceramic that will hold a stone corbel which is in turn embedded into the wall).

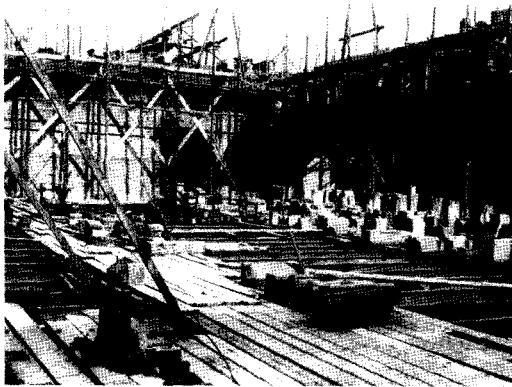
Figure 10

In the main hall of the Stock Exchange looking toward the area of Dam street.

As in the Image 9 before, although the building has not been covered, we are inside a conformed space.

The height of the walls in the biggest hall continues to rise. Beginning of the upper levels. The big lateral arches and the first floor supports have been completed.

The works continue to progress from the area of Dam street. In the background, to the right, we see part of the metallic roofing structure of the Stock Exchange Hall, now Yakult Hall (Image 9). In the wall at the rear, they have begun work on the upper overhanging gallery, with the placement of large

corbels of bevelled and protruding stone. Once embedded in the supporting brickwork, they remain propped up at the end until the suspension is completed with a system of vertical logs and diagonal braces in the form of Saint Andrew's cross, which rest on the ground. At the last level of work, auxiliary lifting constructions and on the ground floor, to the left, a cogged wheel machine with a manual crank. Stockpiling of stone elements, to the right, a piece with carved decoration is marked 91 L*A (the asterisk represents a small illegible sign). Other smaller stockpiles of stone, brick and logs for scaffolding. In the lower left hand corner, the board at the end of the flooring is turned upside down and appears to be equipped with small pieces to fit it over the tie-beams and prevent it from sliding along the floor (however, this does not appear in all of them).

In the wall in the background, in addition to the marks from the putlogs, we can see a slightly sunken horizontal rectangle prepared for a later decorative frieze, which will end up flush with the brickwork.

The photographs reveal that the pieces arrived at the site after being finished in the shop. The finishing work was different on the visible parts than on the hidden parts although they respect the geometry of the planes and edges. This is because the dimensions anticipate their being fit into the brickwork. Thus in the areas where they come into contact with the brickwork, they came in whole kop and laag measurements. The photographs also show the ordering of the stockpiles, and in some cases we can see the designation of pieces, Image 10.

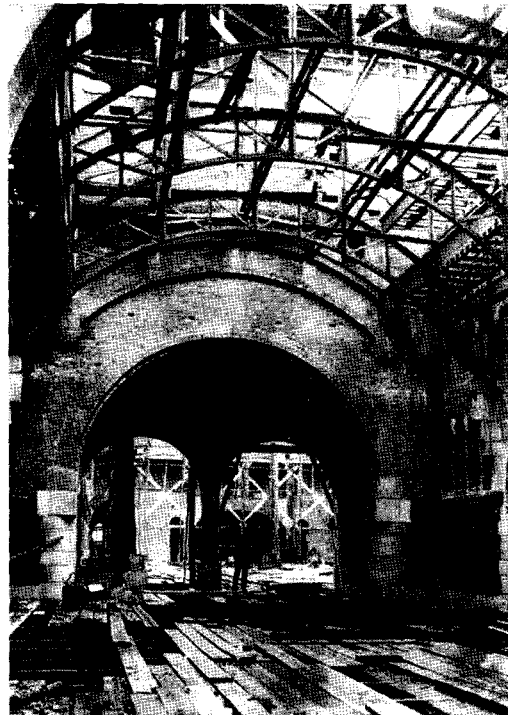
Figure 11

In The Passege, now The Arke Foyer, looking toward the main hall of the Stock Exchange, which can be seen in the background.

We see a structure of metallic roof trusses that have been placed from the interior, and at least part of the exterior of the saddled roof.

The Passege is a hall with a ceiling of uniform height, although it is lower than the other rooms with this type of roof in the central body of the building. It serves as a transition between the two different areas of the building. In the background we see the scaffolding for the series of arches of the main hall.

The roof structure is comprised of different parts. The interior with the lateral horizontal elements which will be covered and the central curved sections which will be transparent. On top, the exterior made of a saddled roof. We see wood logs and planks for the works. Between them, we see two holes in the wall, possibly for access to the inside for maintenance. On the floor, part of the lineal curved elements of the structure and some pieces of stone.

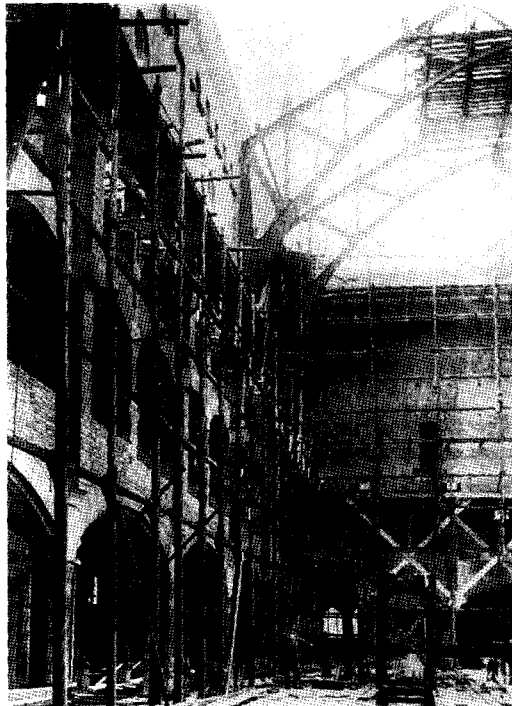
Figure 12

The beams of the floor still have not been filled in.

There remain the marks from the putlogs in the brickwork and some corners have yet to be finished.

The double arch at the end of the barrel vault corresponds to the opposite side described in the formwork phase in Image 7.

In the main hall of the Stock Exchange, looking toward the main entrance on Beursplein street.

It can be seen from the previous image, number 11.

We see the placement of the structure of metallic roof trusses has begun seen from the inside.

It is the hall with the most light. It has a roof structure also composed of different parts. Two roof trusses have been placed in the interior structure and there is auxiliary planking for the workmen in the area of the ridge board. On the floor, on the ridges, we see part of one of the elements.

The wall at the rear, the partition walls of the hall, has been raised up to the horizontal level where the slanted plane of the roof trussing structure begins. Here they have continued with the propping system of vertical logs and diagonal braces in the form of a Saint Andrew's cross, and the system of imposing corbels made of bevelled and protruding stone to support the overhanging gallery until it is stabilised by the weight of the wall. The gallery is vaulted for the floor between corbels. Also, we see the marks in the brickwork made for joining the perpendicular walls to the volume sticking out from underneath the gallery.

In the top floors of the lateral series of arches, the balustrades made of spaced brickwork with decoration are missing. The stone bases of these are also missing.

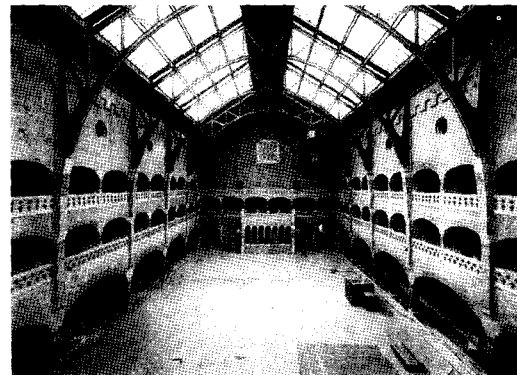
Figure 13

View of the main hall looking toward the main entrance on Beursplein street.

In this hall the works are very advanced.

The roof appears to be finished, even with glass. There is a moving booth suspended from the roof truss at the rear. On the floor there is an area marked off so that the workmen will not walk under the booth.

We cannot see the floor, either because it has not been laid or because it is protected.

Under the series of arches, we see the markings for the installations and on the floor we see rows of stone in the pavement in line with the columns.

There are stockpiles of floorboards and rectangular elements that have been laid down.

The most important panoramic view of the hall in its original configuration. The big arches have not been divided and the trusses do not have braces. These changes were carried out in 1907.

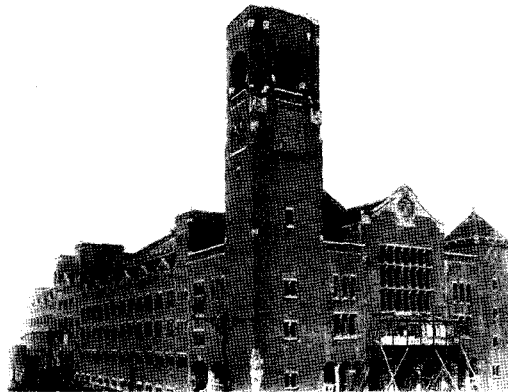
Figure 14

Exterior view of the building with the tower of the main façade toward Beursplein and the western elevation toward Damrak.

We see the building practically finished. They are working on placing the stone bas-relief above the main entrance. Scaffolding and auxiliary work

platform upon which various heavy longitudinal elements have been piled, possibly pieces from the bas-relief as the scaffolding appears to be reinforced. The clock is still missing from the tower.

The perimeter of the work remains fenced off.
